Full Property Inspection Report

SW1A 1AA

IPR-EXAMPLE

24 March 2026

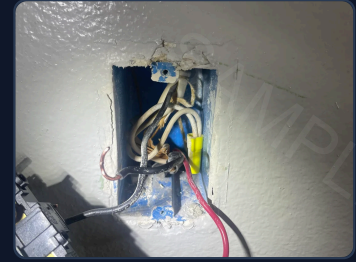
Exposed and improperly terminated wiring

Area: Hallway / Stairs · Detail: Hallway stairs, wall-mounted electrical box

- Electrical wiring in wall-mounted box — multiple exposed wires — improper terminations visible.
- Estimated cost: Under £500
- Electrician: make safe and inspect the affected fitting/cabling where damage is suspected.

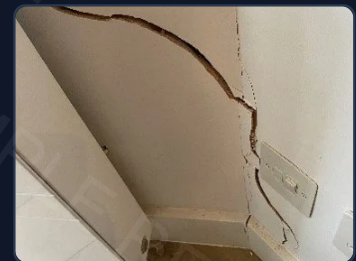
Stepped cracking on internal wall — possible structural movement

Area: Bedroom(s) · Detail: Bedroom, internal wall near skirting and electrical outlet

- Internal wall near skirting — approx. 1.5m stepped crack — visible displacement and plaster detachment.
- Estimated cost: £500–£2,000
- Structural engineer: assess crack pattern and stability urgently.

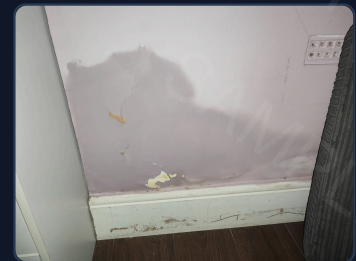
Signs consistent with penetrating damp — wall and skirting level

Area: Bedroom(s) · Detail: Bedroom, lower wall and skirting

- Wall surface at skirting level — approx. 300 mm band — tide-mark staining and plaster flaking.
- Estimated cost: £500–£2,000
- Damp specialist: investigate source of water ingress urgently and make temporary repairs to prevent further damage.

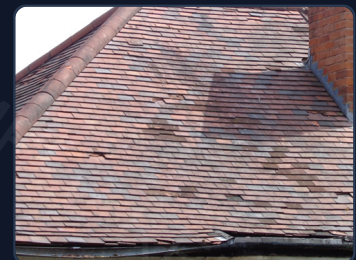
Slipped and Broken Roof Tiles

Area: Roof · Detail: Main roof slope adjacent to chimney

- Roof tiles on main slope near chimney — approx. 15 tiles — slipped, broken, or missing.
- Estimated cost (low confidence): £2,000–£5,000+
- Roofer: make temporarily weather-tight at the affected area where water ingress is suspected.

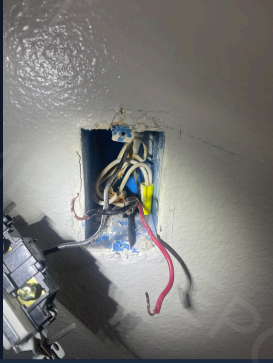
1

- Electrical wiring in wall-mounted box — multiple exposed wires — improper terminations visible.
- Wall-mounted electrical box — no cover or secure fittings — potential live wires exposed.
- Wiring insulation — worn or absent in places — risk of short circuit.

- (Observed #1) Possible aged wiring installation predating modern standards.
- (Observed #2) Possible improper DIY electrical work.
- (Observed #3) Possible lack of maintenance or inspection.

Hallway / Stairs · SRV-001 · Exposed live wiring and improper terminations in a wall-mounted electrical box.

NOW: Electrician: make safe and inspect the affected fitting/cablling where damage is suspected.

SOON: Electrician: test and certify the affected circuit/fittings relevant to the defect location.

If the inspection reveals systemic issues, consider a full Electrical Installation Condition Report (EICR) (£200–£400).

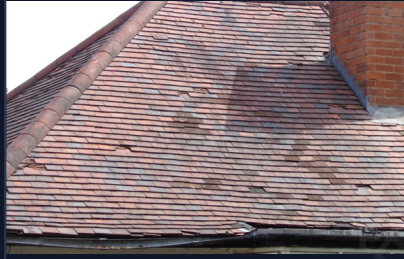
2

- Roof tiles on main slope near chimney — approx. 15 tiles — slipped, broken, or missing.
- Chimney flashing junction — visible gap — potential water entry point.

- (Observed #1) Possible material fatigue or nail failure due to roof age.
- (Observed #2) Possible flashing failure at chimney junction.
- (Observed #1) Possible wind uplift causing tile displacement.

Signs of Water Ingress at Roof Junction — related to Slipped and Broken Roof Tiles above

Roof · ROF-001, ROF-002 · Multiple slipped and broken tiles visible on the pitched roof, concentrated on one slope. (+1 related)

NOW: Roofer: make temporarily weather-tight at the affected area where water ingress is suspected.

SOON: Roofer: replace missing/dislodged tiles and check adjacent tile fixings.

SOON: Roofer: check underlay at exposed areas and confirm laps are intact.

SOON: Internal check: inspect ceiling/wall below for recent staining or dampness.

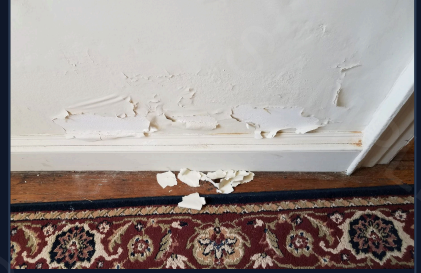
3

- Wall surface at skirting level — approx. 1m wide — peeling paint and plaster deterioration.
- Skirting board at base of wall — localised discolouration — no visible timber decay.

- (Observed #1) Possible rising damp due to absence of damp-proof course.
- (Observed #1) Possible external ground level bridging damp-proof course.

Bedroom(s) · DAM-001 · Peeling paint and plaster deterioration at skirting level in bedroom, consistent with damp-related issues.

SOON: Damp specialist: take moisture profile readings (low-to-high) and check for bridging at external ground levels.

SOON: External check: confirm air bricks/ventilation openings are clear where present.

If damp persists despite external adjustments, engage a damp specialist (£200–£400 investigation, £500–£1,000 treatment per 1m section).

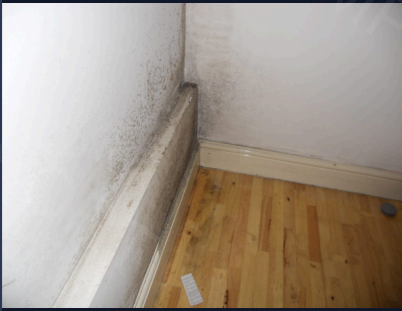
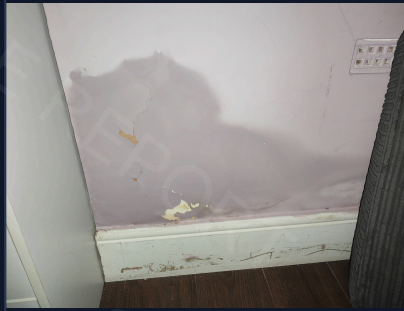
- Wall surface at skirting level — approx. 300 mm band — tide-mark staining and plaster flaking.
- Skirting board — lower edge — paint peeling and discolouration.
- Wall plaster above skirting — approx. 0.5 m² — cracked and deteriorating.

- (Observed #1) Possible defective pointing or render allowing water ingress.
- (Observed #2) Possible high external ground levels bridging DPC.

Mould growth on lower wall and skirting — related to Signs consistent with penetrating damp — wall and skirting level above

Bedroom(s) · DAM-002, DAM-004 · Damp staining and plaster damage visible on lower wall and skirting area, likely from external water ingress. (+1 related)

NOW: Damp specialist: investigate source of water ingress urgently and make temporary repairs to prevent further damage.

SOON: Ventilation: confirm extractor fans operate and discharge externally where applicable.

SOON: Moisture: take moisture readings at affected wall/skirting zones and record results.

SOON: Check: look for local plumbing leak/condensation indicators near the affected area.

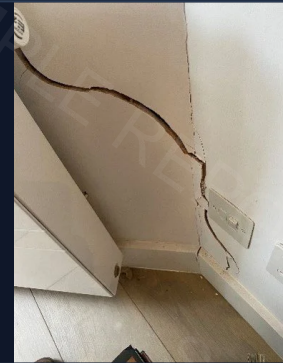
6

- Internal wall near skirting — approx. 1.5m stepped crack — visible displacement and plaster detachment.
- Crack edges near electrical outlet — sharp and irregular — no efflorescence or staining visible.
- Wall surface near crack — plaster bulging and detaching — approx. 200mm affected area.

- (Observed #1) Possible subsidence due to tree root activity.
- (Observed #1) Possible differential settlement of foundation.
- (Observed #1) Possible shrinkage of clay soil during dry periods.

Bedroom(s) · STR-001 · Stepped cracking on internal wall near skirting, extending vertically and horizontally, indicative of movement.

NOW: Structural engineer: assess crack pattern and stability urgently.

SOON: Surveyor/structural engineer (if widening or severity high): assess crack pattern and measure widths at key points.

SOON: Monitoring: record dated photos and crack widths for comparison.

If movement is confirmed, underpinning may be required (£1,500–£3,000 per linear metre).
